Nov 26th, 2024

1248 Rees Dr, Sidney, OH 45365

# Home Inspection Report

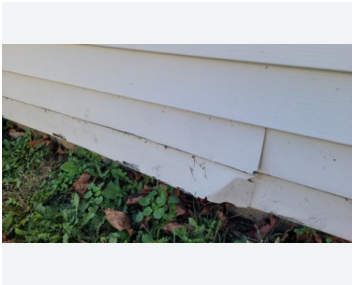
Minor siding damage

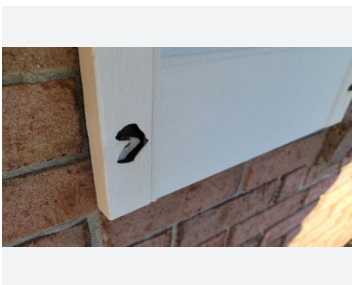
shutter damage

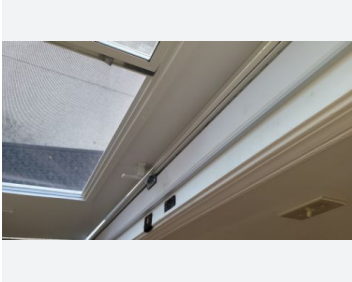
Damaged storm/screen door, rubs on frame, recommend repair

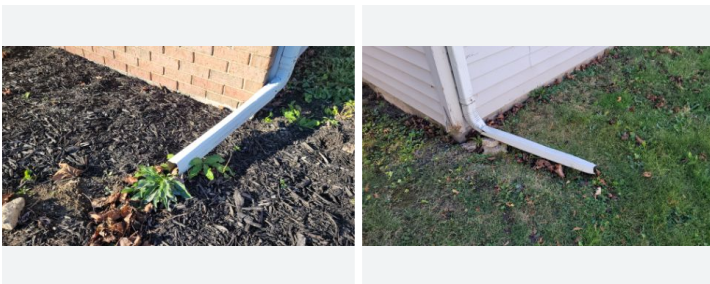
Leader(s) do not extend 6 ft. beyond the foundation perimeter

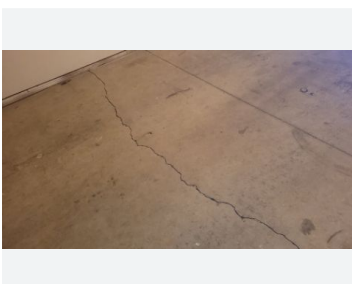
Minor floor crack(s)

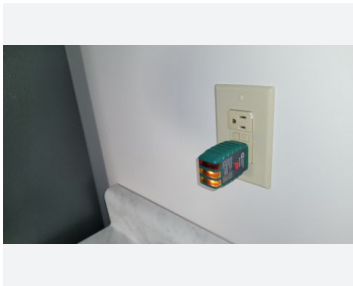
Location - Kitchen

Replace faulty GFCI outlet

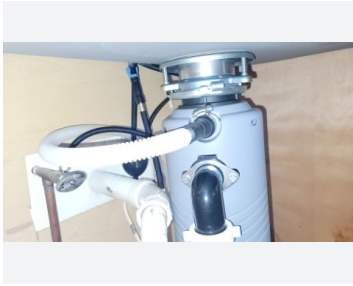
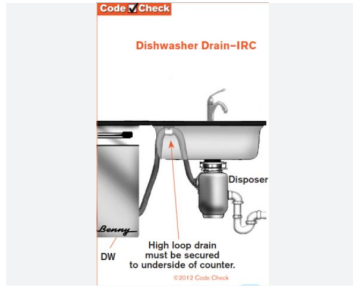
No air gap in the drain hose. Drain hose should be elevated so that there is an air gap in the hose to prevent backflow and siphoning.

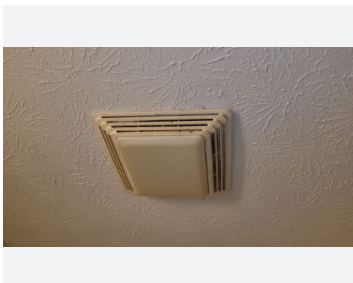
Light inoperative, may be bad bulb

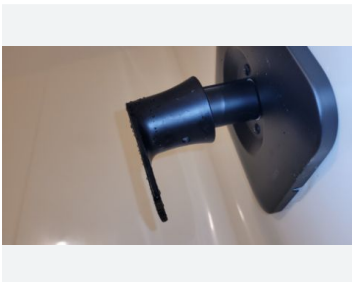
tub faucet handle loose, recommend repair

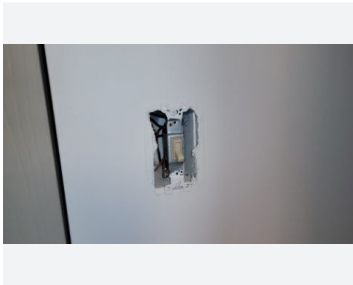
Location - 2nd Bedroom

Install missing outlet/switch cover plate(s)

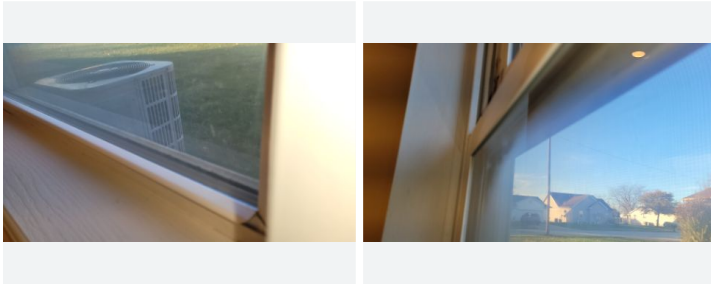
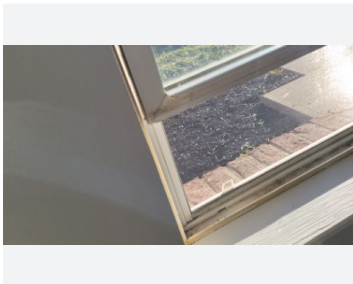
Location - Bedroom

## Window seal broken or damaged

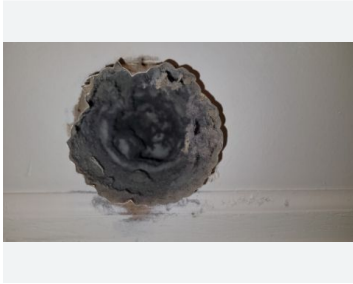
Recommend cleaning dryer vent

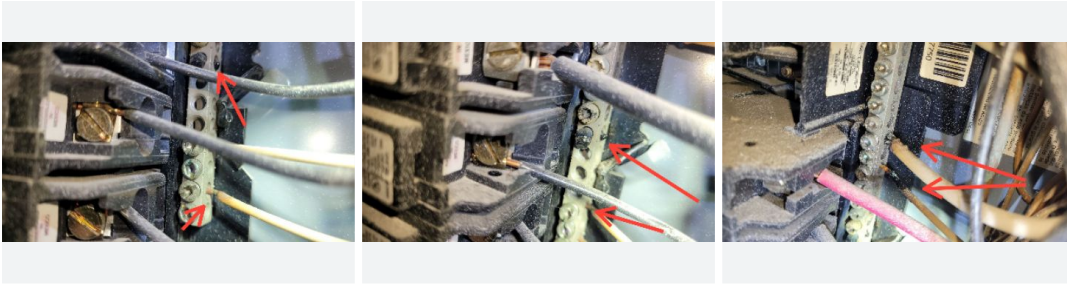
Evidence of overheating circuit recommend evaluation by qualifying electrician  
Location - Garage

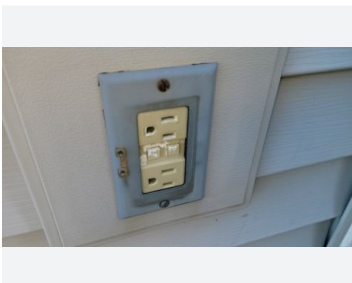
exterior receptacle missing cover, recommend repair

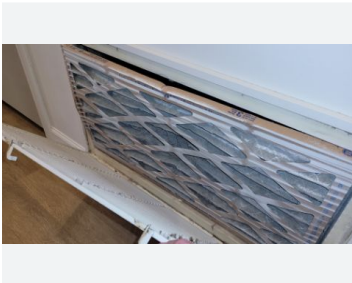
Filter dirty

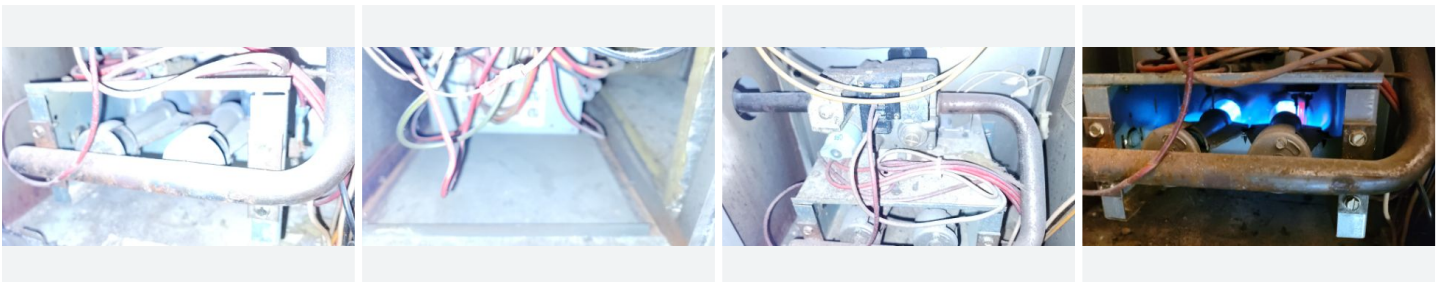
Service recommended

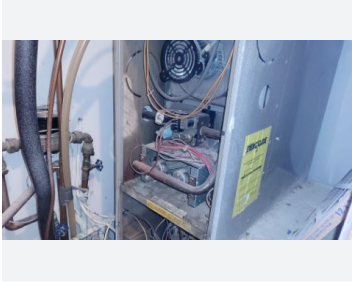
Furnace nearing the end of its design life

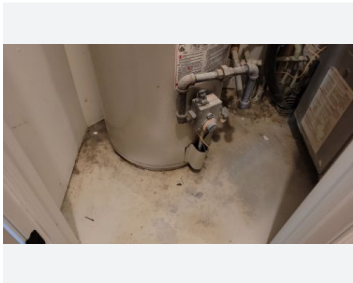
No drip pan present. Recommend one be installed.

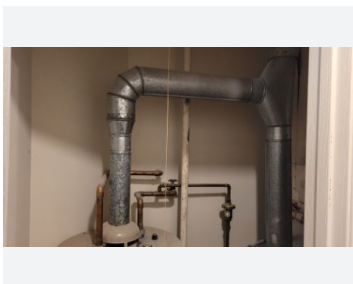
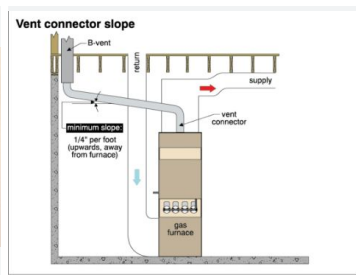
water heater vent flue slope is inadequate and could prevent gases from escaping, recommend flue be adjusted  
Location - Utility room

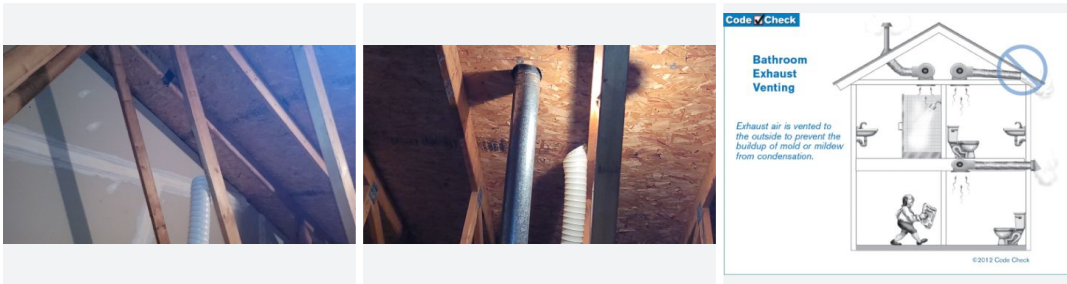
Bathroom vents into attic, this can add moisture to attic and possible organic growth, recommend bathroom vents be exhausted to exterior

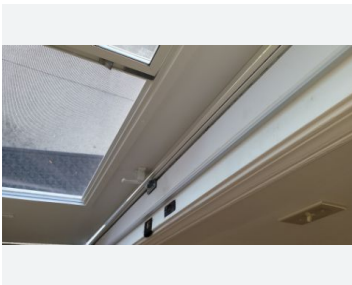
Damaged storm/screen door, rubs on frame, recommend repair

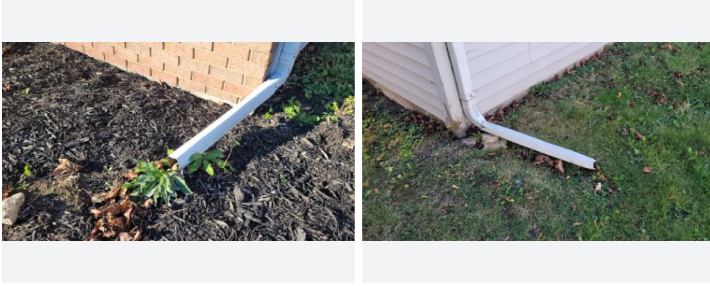
Leader(s) do not extend 6 ft. beyond the foundation perimeter

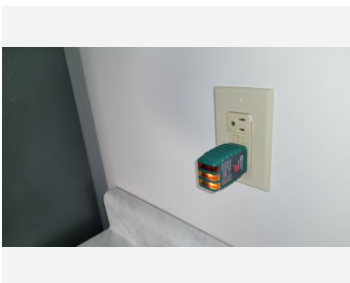
Location - Kitchen

Replace faulty GFCI outlet

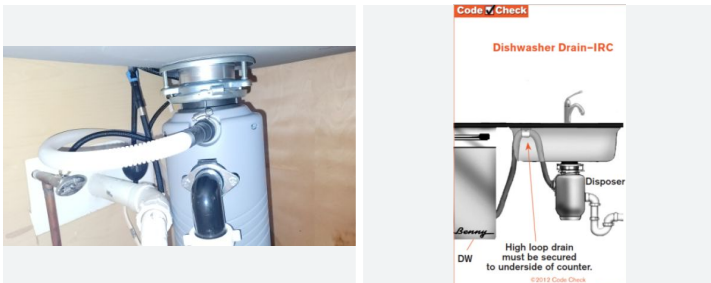
No air gap in the drain hose. Drain hose should be elevated so that there is an air gap in the hose to prevent backflow and siphoning.

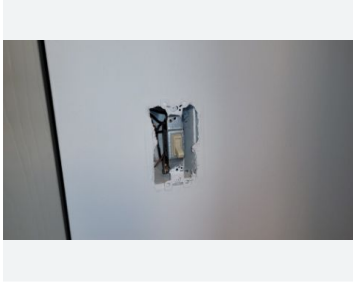
Location - 2nd Bedroom

Install missing outlet/switch cover plate(s)

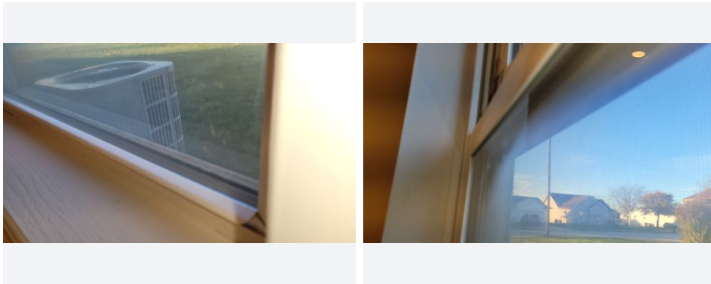
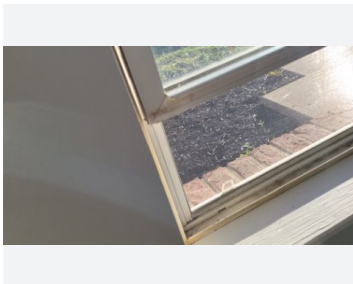
Location - Bedroom

Window seal broken or damaged

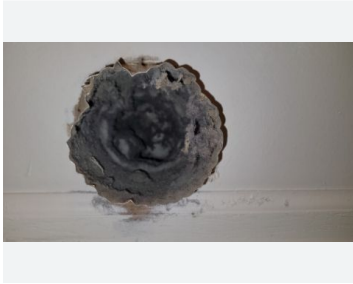
Recommend cleaning dryer vent

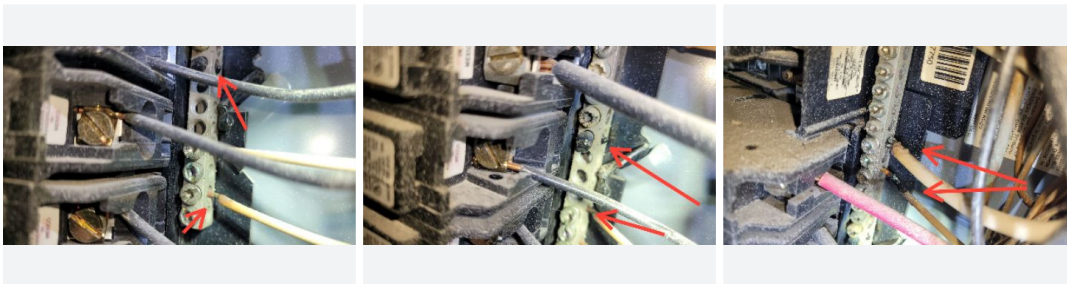
Location - Garage

Evidence of overheating circuit recommend evaluation by qualifying electrician

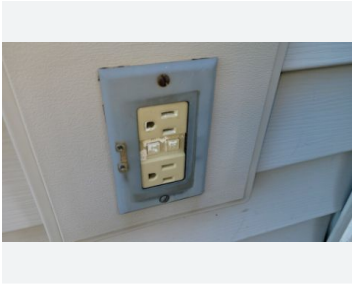
exterior receptacle missing cover, recommend repair

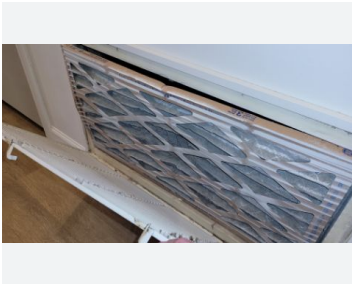
Filter dirty

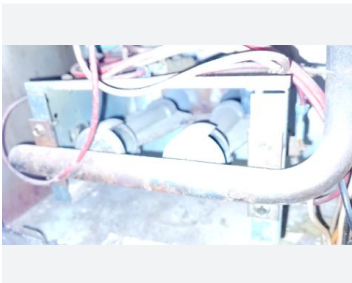
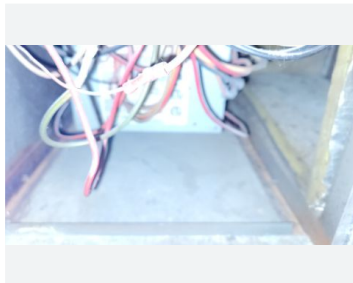
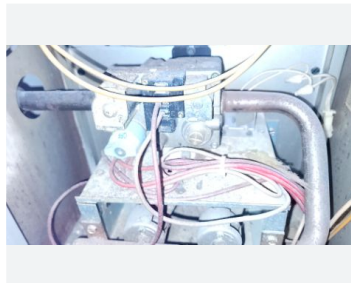
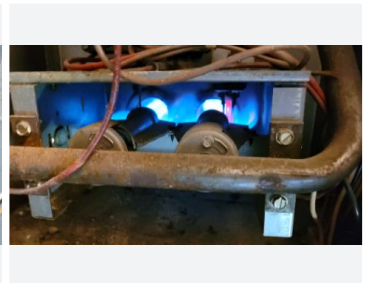
Service recommended

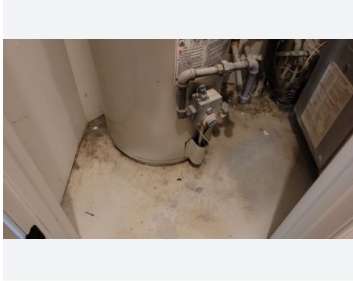
No drip pan present. Recommend one be installed.

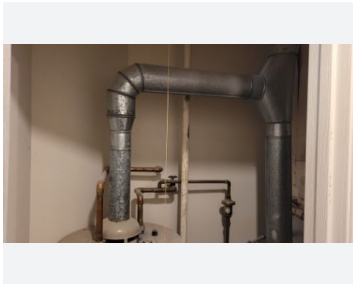
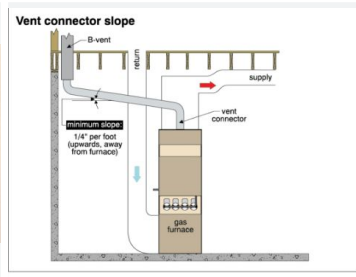
water heater vent flue slope is inadequate and could prevent gases from escaping, recommend flue be adjusted  
Location - Utility room

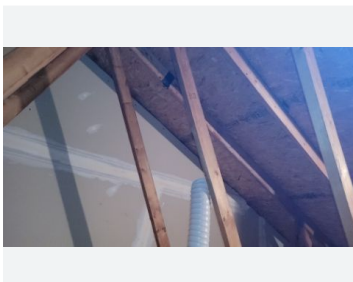
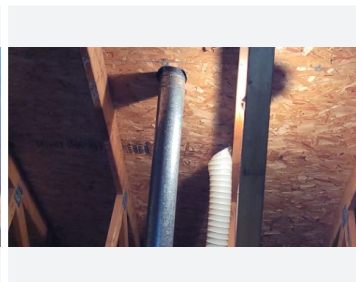
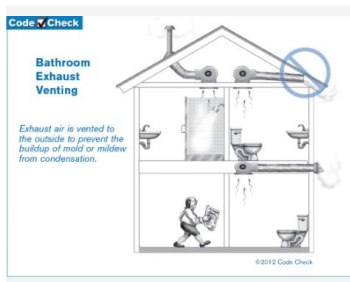
Bathroom vents into attic, this can add moisture to attic and possible organic growth, recommend bathroom vents be exhausted to exterior
